# Test Report

## THOR<sup>SM</sup> Drum Pyrolysis Demonstration

**Rev. 0**  
**March 15, 2004**

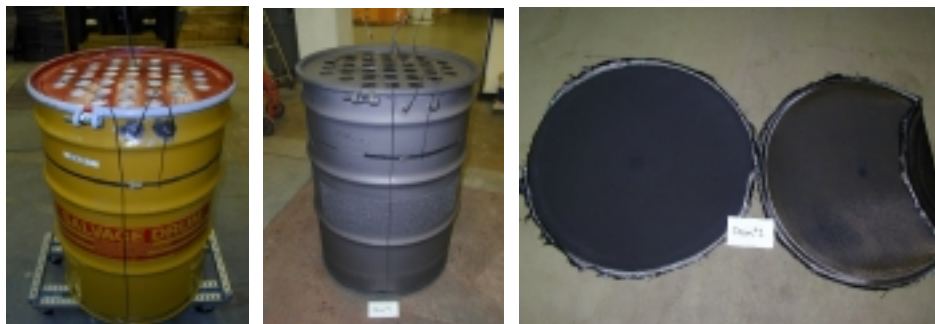
**Figure 9. Drum #1 Following Pyrolysis**

The general appearance of the overpack following pyrolysis is shown in Figure 9. Aside from the light gray color, the overpack was in very good condition, with no damage observed. The filter on the overpack lid was designed to contain non-volatile drum contents during treatment. The total weight of the loaded package decreased from 175.2 lbs to 142.1 lbs, a loss of 33.1 lb or 18.9% as a result of treatment.

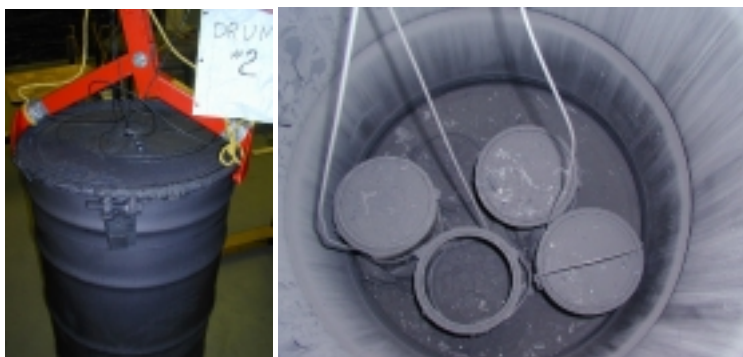
**Figure 14. Drum #2 Following Pyrolysis**  
**Figure 15. The Interior of Drum #2 Following Pyrolysis**

Following cool-down, the drum was removed from the pyrolyzer and was inspected. The general appearance of the drum following pyrolysis is shown in Figure 14, along with the drum-lifting tool. Aside from the gray color and the presence of a light residue of flaking paint, the drum was in good condition, with no damage apparent. The drum closure ring was loose because the lid gasket had been volatilized. The total weight of the loaded drum decreased from 107.0 lbs to 88.5 lbs, a loss of 18.5 lbs or 17.4% as a result of treatment.

The lid was then removed from the 55-gallon drum, revealing the contents as shown in Figure 15. Upon removal from the drum, the contents appeared as shown in Figure 16. All of the cans in the drum were breached.

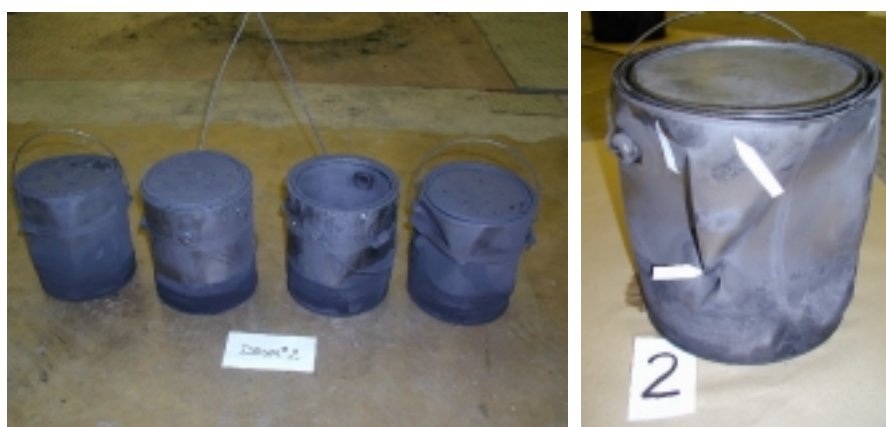
**Figure 16. The Contents of Drum #2 Following Pyrolysis**  
**Figure 17. Paint Can from Drum #2 After Pyrolysis. Arrows indicate Leak Points**

The lid of the can that had contained ~1 cup of paint had popped off and was lying upside down on the bottom of the drum. The can contained pyrolyzed paint flake residues that looked much like dried cake on a dried lakebed. The sides of the can had slightly buckled inward.

The can that had contained the scrap metal with the plastic bags and tape had sustained significant deformation of the sides and there was an ~1/8-inch gap between the lid and the top of the can at one point. The lid itself was not deformed.

The can that had contained the scrap metal without the plastic bags and tape had sustained heavy buckling, but there was no visually apparent gap or leak point at the lid. When the can was submerged in 3–4 inches of water, the can leaked in three places (see Figure 17, leak points are noted with white arrows). The lid seal leaked in two places and a crease in the side had an even larger leak.

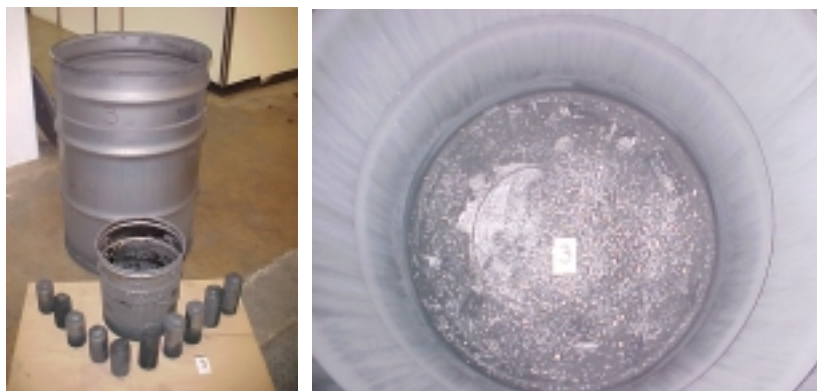
**Figure 22. The Bottom of Drum #3 Following Pyrolysis with cans removed**

There was an ~2-inch high black “bathtub ring” at the bottom of the 55-gallon drum, as shown in Figure 22. This was a thin film of carbon-rich char residue from the melting, pooling, and ultimate volatilization of the drum liner. This ring was also apparent on the aerosol cans shown in Figure 21. There were also black streaks apparent down the inside of the drum indicating the flow of the melting drum liner.

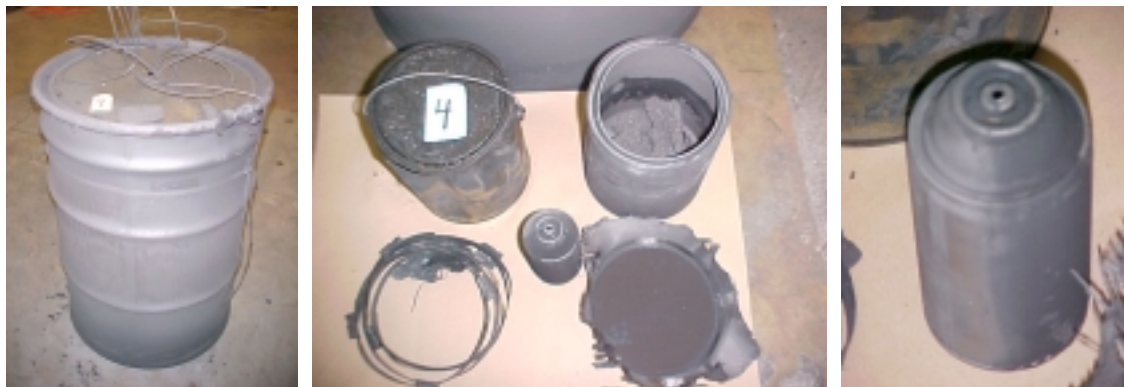
**Figure 25. Drum #4 Following Pyrolysis**

Following cool-down, the drum was removed from the pyrolyzer and was inspected. The general appearance of the drum following pyrolysis is shown in Figure 25. Aside from the gray color and the presence of a light residue of flaking paint on the lid, the drum was in good condition, with no damage apparent. The seal on the drum lid had been lost, as the lid gasket was pyrolyzed with only a carbon residue remaining in the lid groove. The total weight of the drum decreased from 108.7 lbs to 86.6 lbs, a loss of 22.1 lbs or 20.3% as a result of treatment.

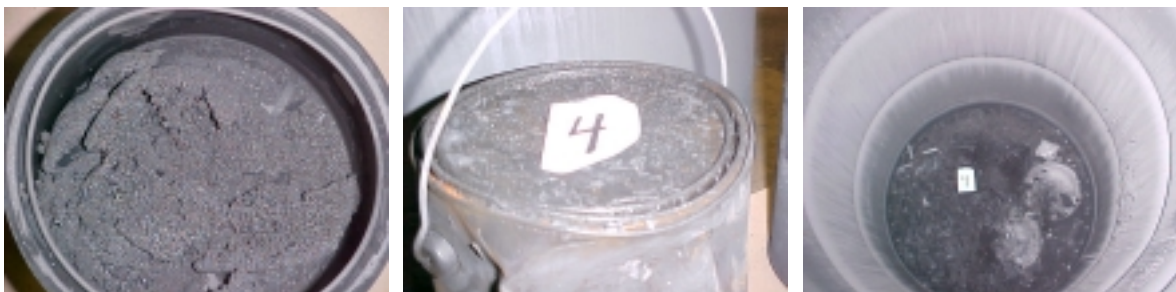
The 1-gallon can that had contained the anion exchange resin is pictured in Figure 28. The bottom of the can was bulged outward ~1/2 inch. The filter material covering the can was stiff and bowed upward and had an ~1/8 inch black coating on the inside surface. The resin inside the can was reduced to ~1/6<sup>th</sup> its original volume and was friable.

**Figure 28. 1-Gallon Can of Anion Exchange Resin from Drum #4 Following Pyrolysis**

**Figure 29. 1-Gallon Can of Scrap Metal from Drum #4 Following Pyrolysis**

The 1-gallon paint can containing scrap metal and plastic is pictured in Figure 29. The can was severely buckled and the lid was lifted slightly in two areas. The can exhibited significant leakage at the lid when submerged in water.

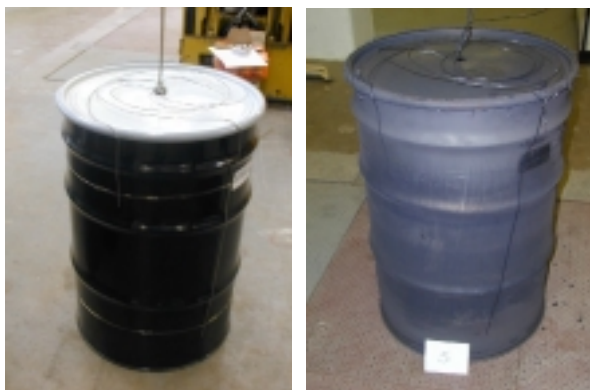
**Figure 31. Drum #5 Ready for Pyrolysis**  
**Figure 32. Drum #5 Following Pyrolysis**

Following cool-down, the drum was removed from the pyrolyzer and was inspected. The general appearance of the drum following pyrolysis is shown in Figure 32. Aside from the light gray to black color, the drum was in very good condition, with no damage observed. The seal on the drum lid had been lost, as the lid gasket was pyrolyzed leaving only a friable residue in the lid groove. The total weight of the drum decreased from 78.7 lbs to 62.7 lbs, a loss of 16.0 lbs or 20.3% as a result of treatment.

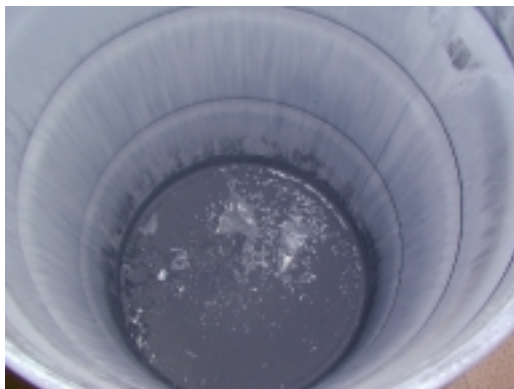
**Figure 33. Bottom of Drum #5 Following Pyrolysis**

All that remained in the drum from the plastic tubing and the plastic bags and tape were the remains of the tape sleeves, much reduced in volume and highly friable. There was an ~2-inch high black “bathtub ring” at the bottom of the 55-gallon drum, as shown in Figure 33. This was a film of carbon-rich char residue from the melting, pooling, and ultimate volatilization of the drum liner. There were also black streaks apparent down the inside of the drum indicating the flow of the melting drum liner.

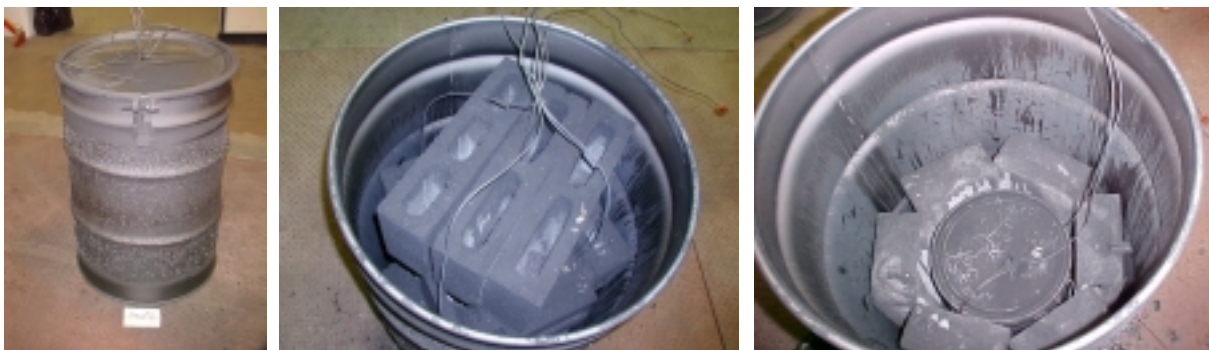
**Figure 36. Drum #6 Following Pyrolysis**

color and the presence of a large area of light residue of flaking paint, the drum was in good condition, with no damage apparent. The seal on the drum lid had been lost, as the lid gasket was pyrolyzed leaving only a friable residue in the lid groove. The total weight of the drum decreased from 357.0 lbs to 326.2 lbs, a loss of 30.8 lbs or 8.6% as a result of treatment.

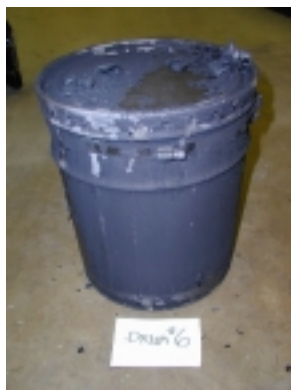
**Figure 39. 5-Gallon Can from Drum #6 Following Pyrolysis**

The 5-gallon paint can that had contained ~1cup of paint was coated with a cracked black crust ~1/16 inch thick that required mechanical action to dislodge (see Figure 39). This coating was probably the result of the melting plastic in the drum running down onto the can and then pyrolyzing. The can lid was loose, its gasket having been volatilized away. There was ~1/8 inch thick cracked carbonized paint residue inside the can, looked much like a dried lakebed. There was no bulging or deformation of the can body.

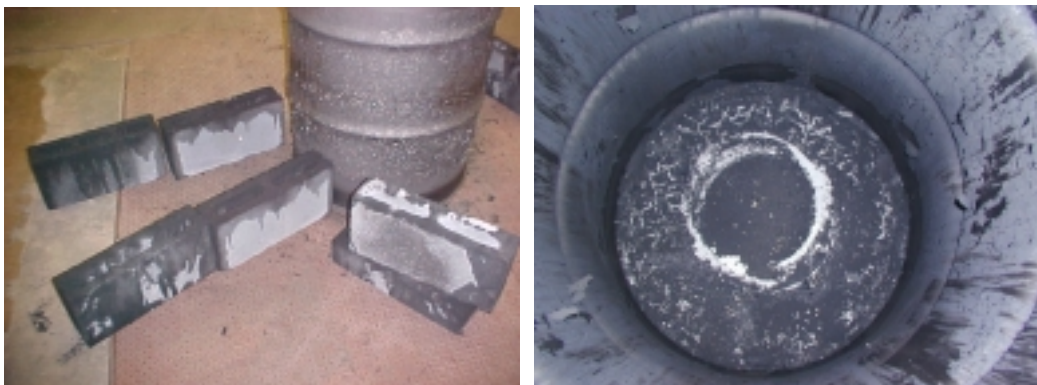
**Figure 40. Concrete Blocks from Drum #6 Following Pyrolysis**

The concrete blocks that had been placed into the drum were fully intact, but had been stained by the melting/pyrolyzing plastic liner and bags (see Figure 40).

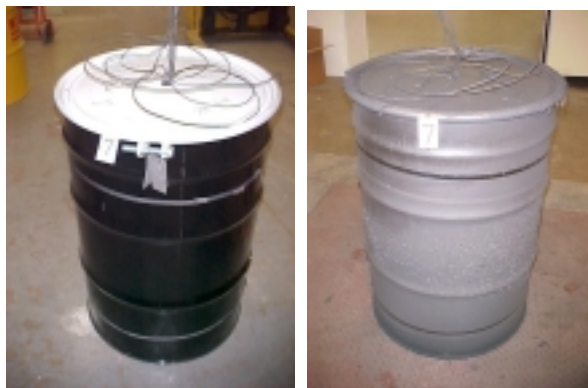
**Figure 42. Drum #7 Ready for Pyrolysis**  
**Figure 43. Drum #7 Following Pyrolysis**

Following cool-down, the drum was removed from the pyrolyzer and the package was inspected. The general appearance of the 55-gallon drum following pyrolysis is shown in Figure 43. Aside from the light gray color and the presence of a light residue of flaking paint, the drum was in good condition, with no damage apparent. The seal on the drum lid had been lost, as the lid gasket was pyrolyzed with only a friable residue remaining in the lid groove. The total weight of the loaded drum decreased from 113.5 lbs to 86.8 lbs, a loss of 26.7 lb or 23.5% as a result of treatment.

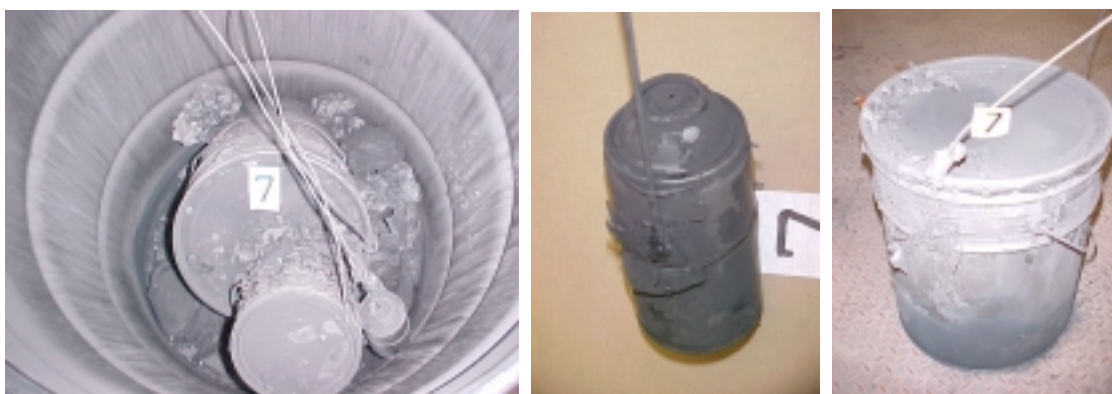
The lid was then removed from the 55-gallon drum, revealing the contents as shown in Figure 44. All of the cans in the drum were breached.

**Figure 45. Aerosol Can from Drum #7 Following Pyrolysis**

The plastic stem in the aerosol can was gone and the top can seal turned freely. A rod dropped into the stem hole fell immediately to the bottom. There were no bulges or dents in the can. There was a dark stain on the aerosol can, probably from the melting and subsequent pyrolysis of the plastic bags in which it had been wrapped (see Figure 45). Note the thermocouple still attached.

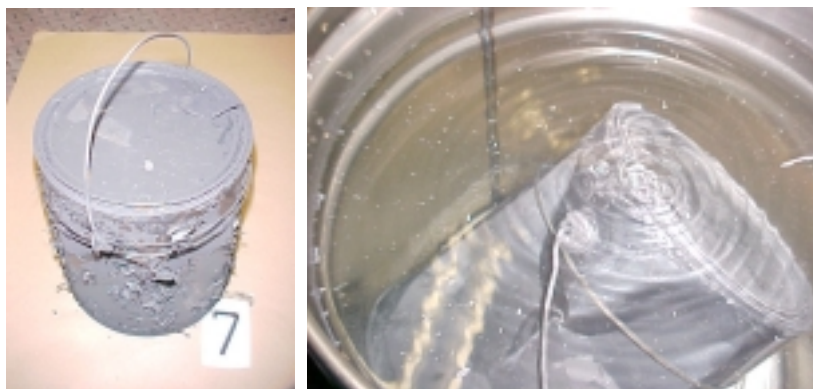
**Figure 47. 1-Gallon Paint Can from Drum #7 Following Pyrolysis**  
**Figure 48. 1-Gallon Can from Drum #7 During Post-Pyrolysis Leak Testing**

The 1-gallon paint can with the scrap metal and plastic had its lid bent upward slightly in one area, as shown in Figure 47. The can's side was also dented and upon submergence in water, air bubbled profusely from the can lid, as seen in Figure 48, clearly indicating the can was breached.

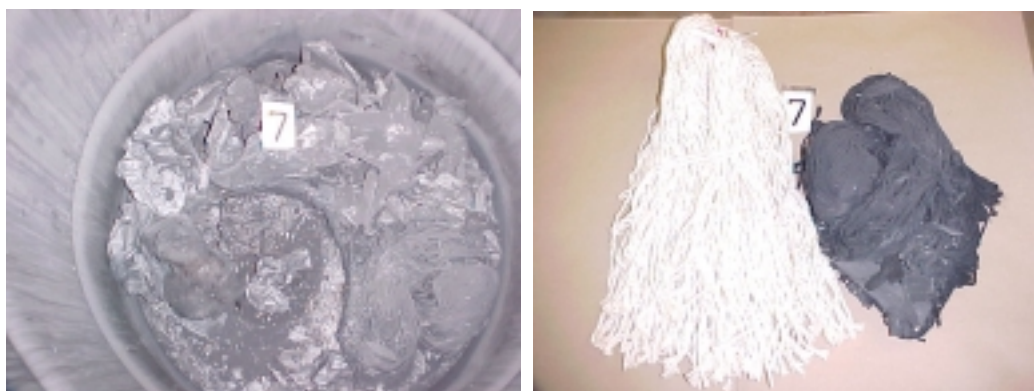
**Figure 49. The Remains of the Paper and Mop Heads Pyrolyzed in Drum #7**  
**Figure 50. A Pyrolyzed Mop Head from Drum #7 Compared to an Untreated Mop Head**

The absorbent wipes and the craft paper were both greatly reduced in mass and volume and were very friable, much like newspaper ash. The mop heads had shrunk in volume ~50% and were greatly reduced in mass. The strings could be easily broken apart by hand, but were not as friable as the paper following pyrolysis. Figure 49 shows the remains of these items in the bottom of the drum following pyrolysis. Figure 50 shows a mop head after pyrolysis, as compared to an untreated mop head.

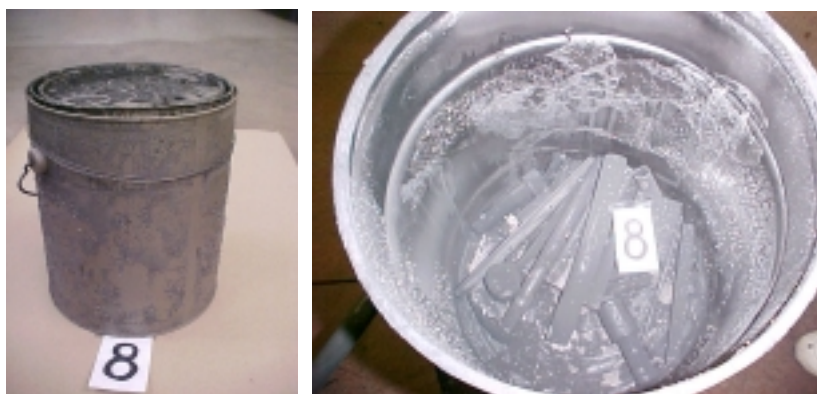
**Figure 56. 1-Gallon Can from Drum #8 Following Pyrolysis**

The 1-gallon paint can that had contained 1 cup of water had its lid bent upward around an ~120° arc and was clearly open, as shown in Figure 56. There was no bulging or deformation of the can body. When submerged under an inch of water, a steady stream of bubbles issued from the 1-gallon can lid.
