# Test Report

## THOR<sup>SM</sup> Drum Pyrolysis Demonstration

**Rev. 0**  
**March 15, 2004**

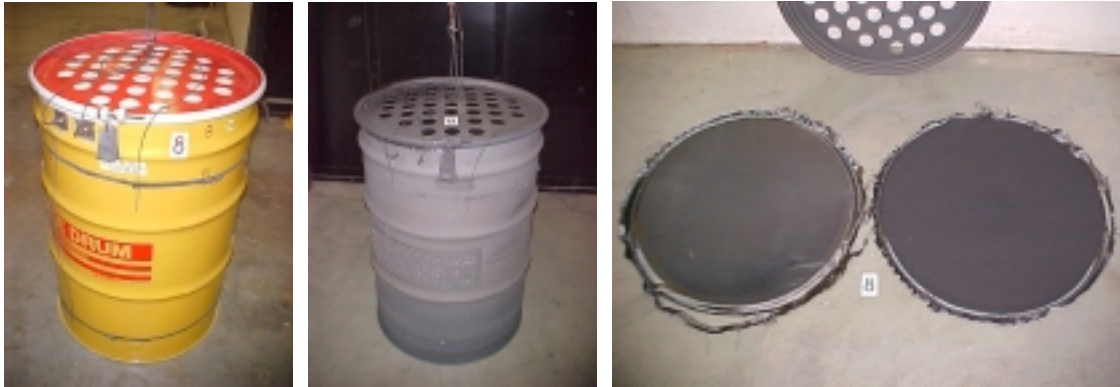
**Figure 52. Drum #8 Following Pyrolysis**

The general appearance of the overpack following pyrolysis is shown in Figure 52. Aside from the light gray color from pyrolyzed paint, the overpack was in very good condition, with no damage observed. The total weight of the package decreased from 240.0 lbs to 203.2 lbs, a loss of 36.1 lbs or 15.3% as a result of treatment.

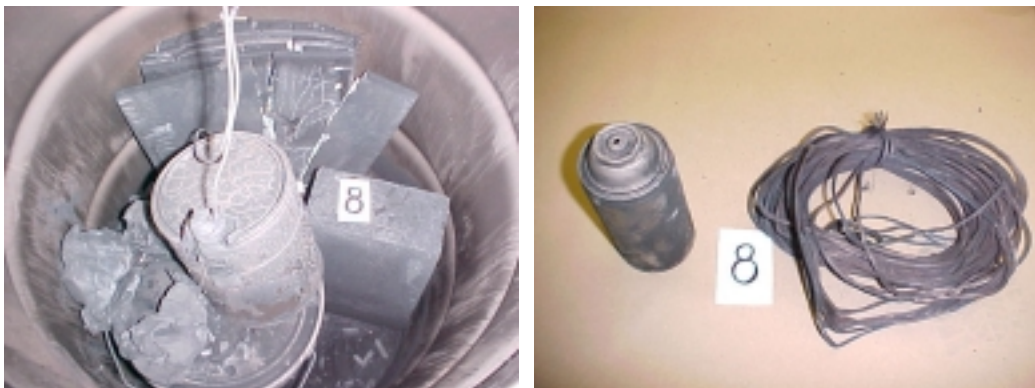
**Figure 54. The Interior of Drum #8 Following Pyrolysis**

The inner 55-gallon drum was removed from the overpack, inspected, and weighed. The lid was then removed, revealing the contents as shown in Figure 54. All of the cans in the drum were breached. The total weight of the drum decreased from 161.1 lbs to 125.0 lbs, a loss of 36.1 lbs or 22.4% as a result of treatment.

The plastic stem in the aerosol can was gone and the top can seal turned freely (see Figure 55). A rod dropped into the stem hole of the aerosol can fell immediately to the bottom.

The 1-gallon paint can that had contained 1 cup of water had its lid bent upward around an ~120° arc and was clearly open, as shown in Figure 56. There was no bulging or deformation of the can body. When submerged under an inch of water, a steady stream of bubbles issued from the 1-gallon can lid.

The balance of drum contents is shown in Figure 54 and Figure 57. The paper coating on the gypsum sheet rock was gone and the gypsum itself was friable, and partially broken. The craft paper was greatly reduced in mass and volume and was very light and friable, like newspaper ash. The absorbent wipes were much the same. The 12-gage insulated wire was as shown in Figure 55. The insulation was reduced to a dark crusty residue.

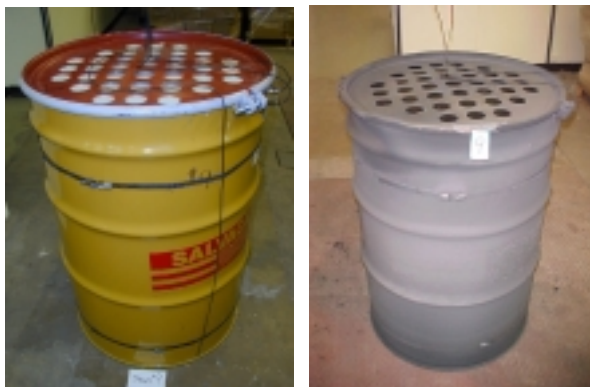
**Figure 58. Drum #9 Ready for Pyrolysis**  
**Figure 59. Drum #9 Following Pyrolysis**

The general appearance of the overpack following pyrolysis is shown in Figure 59. Aside from the light gray color from pyrolyzed paint, the overpack was in good condition, with no damage observed. The total weight of the package decreased from 335.8 lbs to 282.2 lbs, a loss of 53.6 lbs or 16.0% as a result of treatment.

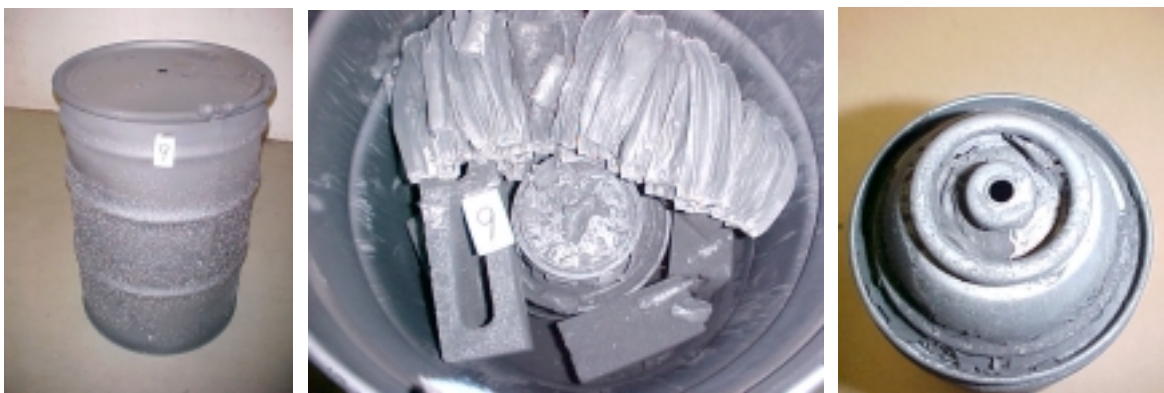
**Figure 60. Drum #9 Inner 55-Gallon Drum Following Pyrolysis**

The 55-gallon drum was in good condition, with a nearly clean lid and a very light flaking paint residue on the sides (see Figure 60). The lid was then removed, revealing the contents as shown in Figure 61. All of the cans in the 55-gallon drum were breached. The 55-gallon drum was removed from the overpack and weighed. The total weight of the drum decreased from 257.0 lbs to 203.2 lbs, a loss of 53.8 lbs or 20.9% as a result of pyrolysis.

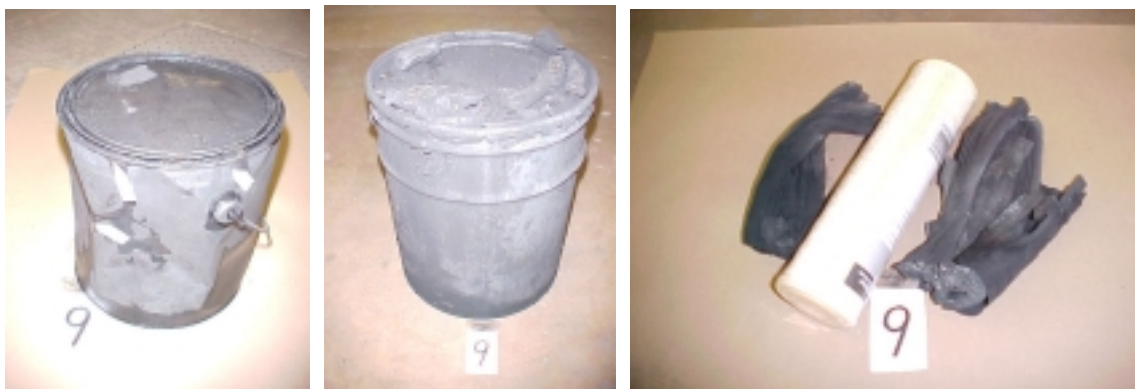
The 1-gallon paint can that had contained 2 cups of paint was badly deformed, as shown in Figure 63. The can lid was clearly not sealed upon observation. When submerged under 3-4 inches of water, a steady stream of bubbles issued from the can lid and from a breach in its side (at the point of sharp buckling in side of can). The interior of the 1-gallon can contained only a light, cracked paint residue.

The 5-gallon paint can that had contained scrap metal and plastic bags had a loose lid, with its gasket mostly volatilize away. There was no bulging or deformation of the can body (see Figure 64).

**Figure 63. 1-Gallon Can from Drum #9 Following Pyrolysis**

**Figure 64. Exterior of 5-Gallon Can from Drum #9 Following Pyrolysis**

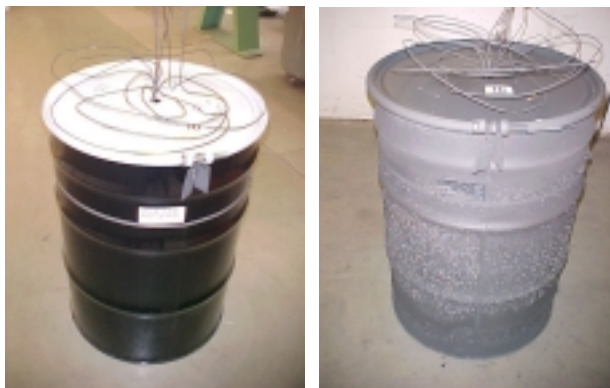
**Figure 66. Drum #10 Ready for Pyrolysis**  
**Figure 67. Drum #10 Following Pyrolysis**

Following cool-down, the drum was removed from the pyrolyzer and the package was inspected. The general appearance of the 55-gallon drum following pyrolysis is shown in Figure 67. Aside from the gray color and the presence of a light residue of flaking paint, the drum was in good condition, with no damage apparent. The total weight of the drum decreased from 305.0 lbs to 273.7 lbs, a loss of 31.3 lbs or 10.3% as a result of treatment. This small weight reduction was not surprising, given the small percentage of organic constituents in the initial package.

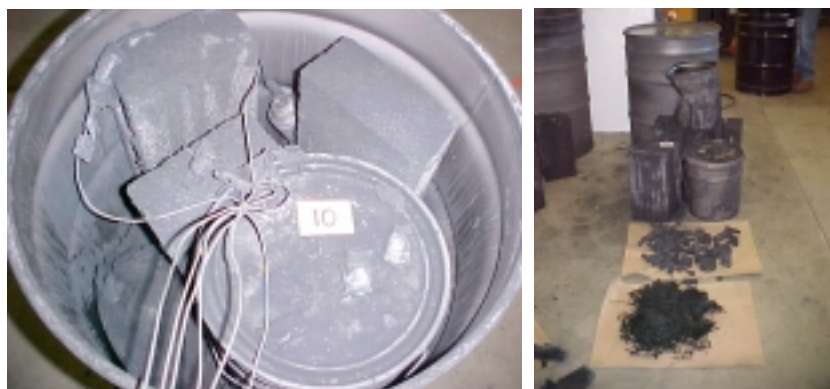
**Figure 68. The Interior of Drum #10 Following Pyrolysis**  
**Figure 69. The Contents of Drum#10 Following Pyrolysis**

The lid was then removed from the 55-gallon drum, revealing the contents as shown in Figure 68. Upon removal from the drum, the contents appeared as shown in Figure 69. All of the cans in the drum were breached.

The plastic stem in the aerosol can was gone and the top can seal turned freely. A rod dropped into the stem hole fell immediately to the bottom. There were no bulges or dents in the aerosol can.

The 5-gallon paint can that had contained the scrap metal and plastic bags was badly deformed, as can be seen in Figure 69. This was from the weight of the concrete blocks on top of the can, combined with the elevated pyrolysis temperatures. The can lid was loose, its gasket having mostly volatilized. The residual gasket comprised friable carbon residues.
